# **BATTLESHIP TEXAS (BB-35)**

## **VESSEL INSPECTION AND ASSESSMENT**

Vessel Survey Report No. 2417

Vessel surveyed at:	La Porte, Texas
Dates of survey:	November - December 2010 January 2011
Vessel surveyed:	Battleship TEXAS (BB-35)
Survey commissioned by:	Texas Parks & Wildlife Battleship TEXAS State Historic Site 3523 Independence Parkway South La Porte, Texas 77571
Purpose of survey:	Vessel Condition Survey

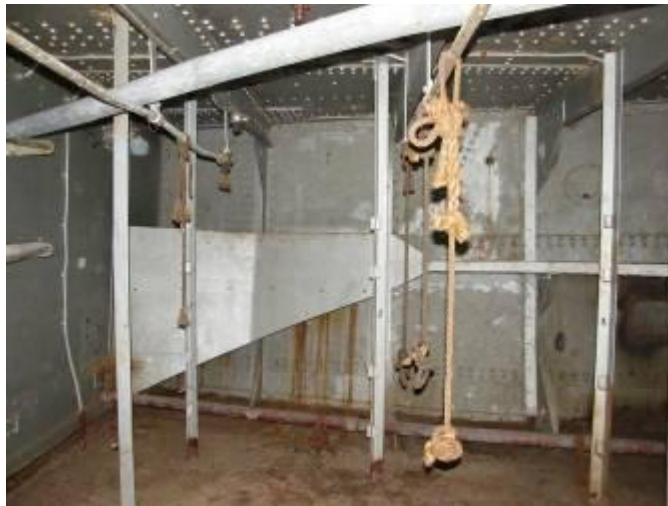
Figure 296 Hold (A – 29, Frames No. 14 – 18)

This space is in good structural and fair cosmetic condition.

**Prepare, prime and paint space.**

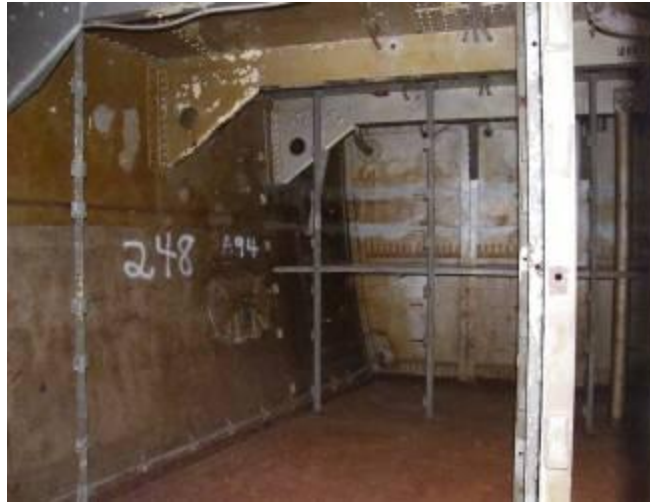
**Figure 297 GSK Stores (A – 30 – P, Frames No. 18 – 24; Port)**

This space is in good structural and fair cosmetic condition.

<p><b>Prepare, prime and paint space.</b></p>
---

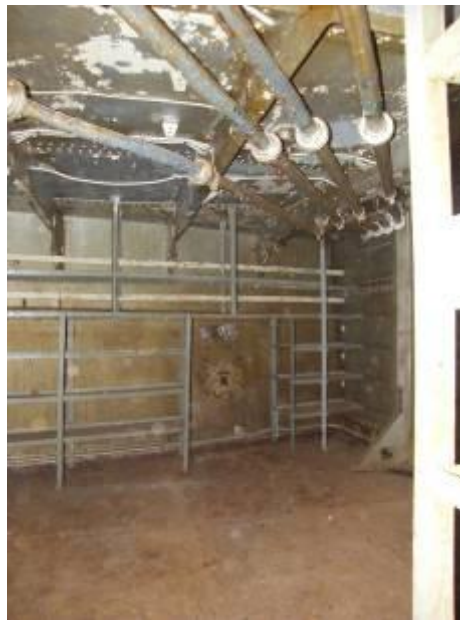
**Figure 298 GSK Stores (A-30-S, Frames No. 18 – 24; Starboard)**

This space is in good structural and fair cosmetic condition.

<p><b>Prepare, prime and paint space.</b></p>
---

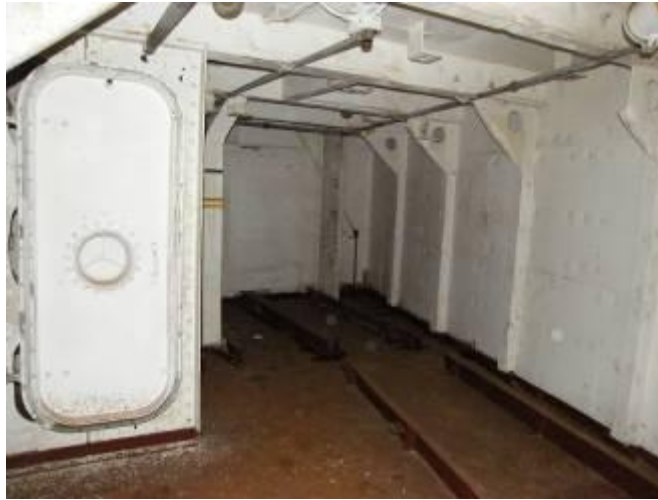
**Figure 299 3" Magazine (A-34-M-P; Port)**

This space is in good structural and fair cosmetic condition

**Prepare, prime and paint space.**

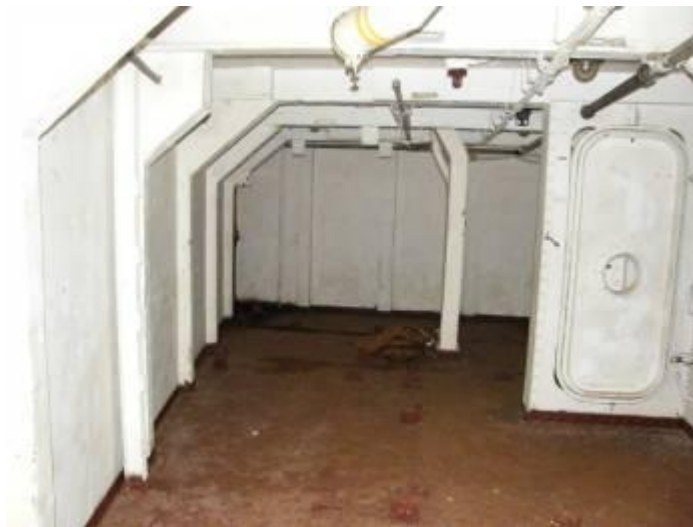
**Figure 300 Small Arms Magazine (A-34-M-S; Starboard)**

This space is in good structural and fair cosmetic condition.

**Prepare, prime and paint space.**

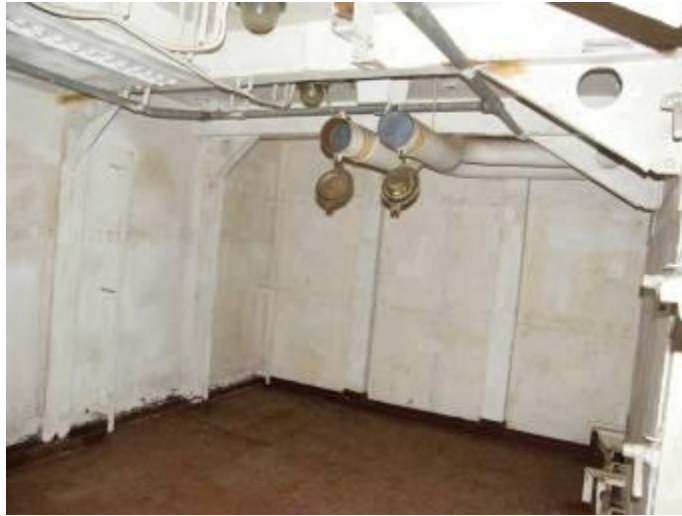
**Figure 301 3" A.A. Magazine (A-33-M-P; Port)**

This space is in good structural and fair cosmetic condition.

<p><b>Prepare, prime and paint space.</b></p>
---

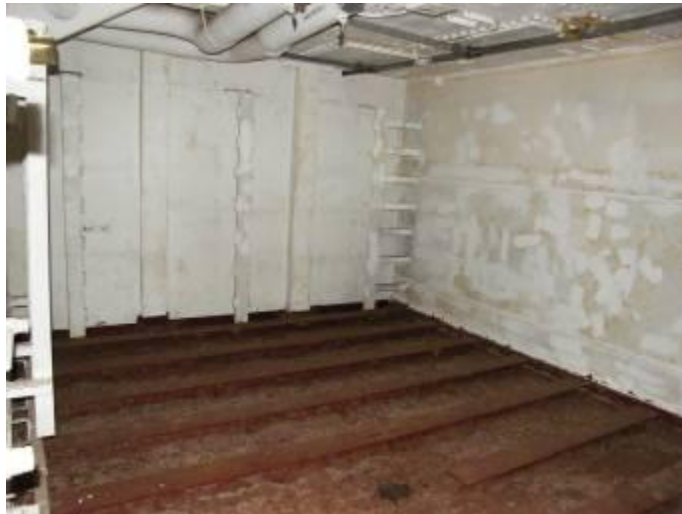
**Figure 302 40 MM A.A. Storage Magazine (A-33-M-S; Starboard)**

This space is in good structural and fair cosmetic condition.

<p><b>Prepare, prime and paint space.</b></p>
---

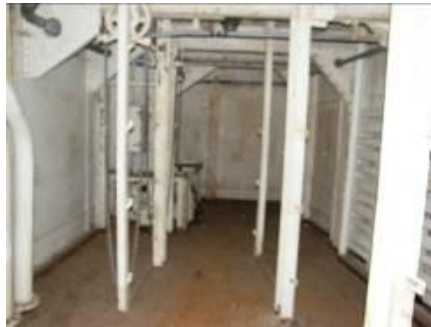
**Figure 303 Ordnance Storeroom (A-35-P; Port)**

This space is in good structural and fair cosmetic condition.

**Prepare, prime and paint space.**

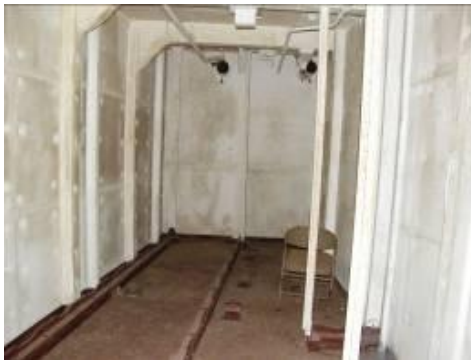
**Figure 304 3" Magazine (A-36-P; Port)**

This space is in good structural and fair cosmetic condition.

**Prepare, prime and paint space.**

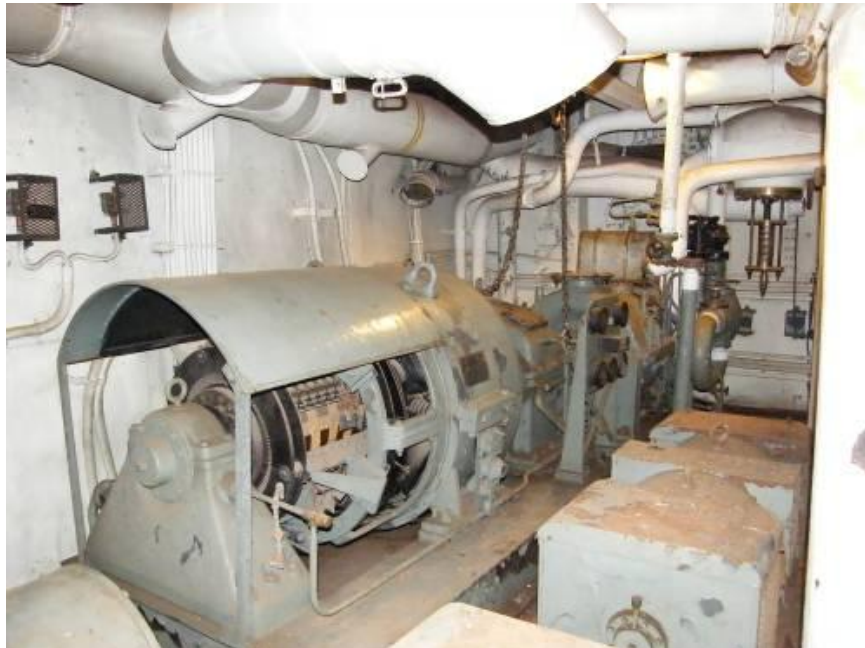
**Figure 305 Forward Dynamo Room (A-39; Centerline)**

This space is in good structural and fair cosmetic condition.

<b>Prepare, prime and paint space.</b>
--

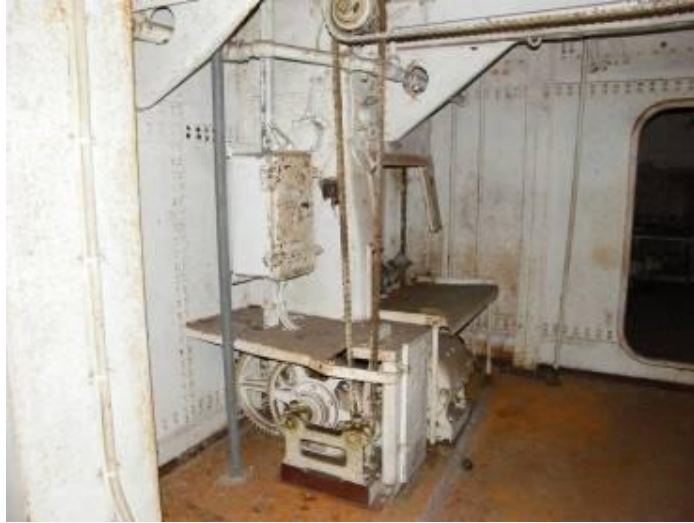
**Figure 306 3" Shell and Handling Room (A-38-M-P; Port)**

This space is in good structural and fair cosmetic condition.

<b>Prepare, prime and paint space.</b>
--

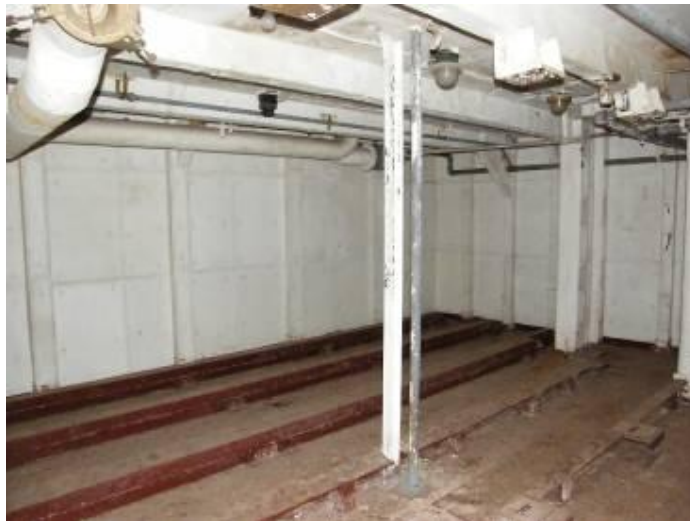
**Figure 307 5" Shell and Handling Room (A-38-M-S; Starboard)**

This space is in good structural and fair cosmetic condition.

<b>Prepare, prime and paint space.</b>
--

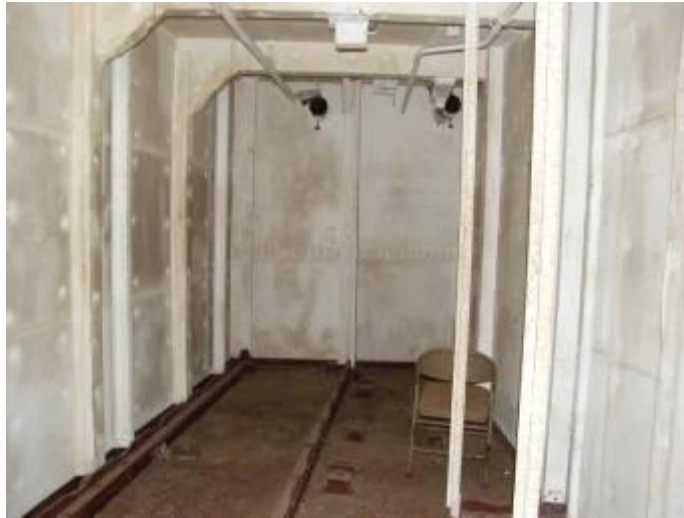
**Figure 308 5" Shell and Handling Room (A-40-M-P; Port)**

This space is in good structural and fair cosmetic condition.

<p><b>Prepare, prime and paint space.</b></p>
---

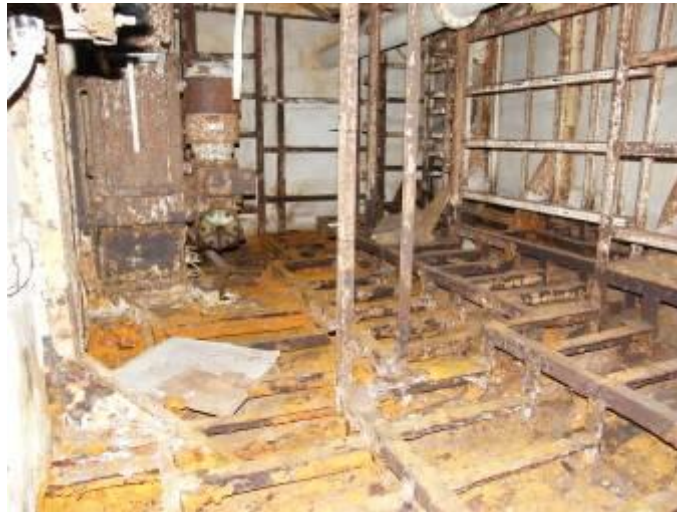
**Figure 309 5" Shell and Handling Room (A-38-M-S; Starboard)**

This space is in fair structural and poor cosmetic condition.

<p><b>Prepare, prime and paint space.</b></p>
---

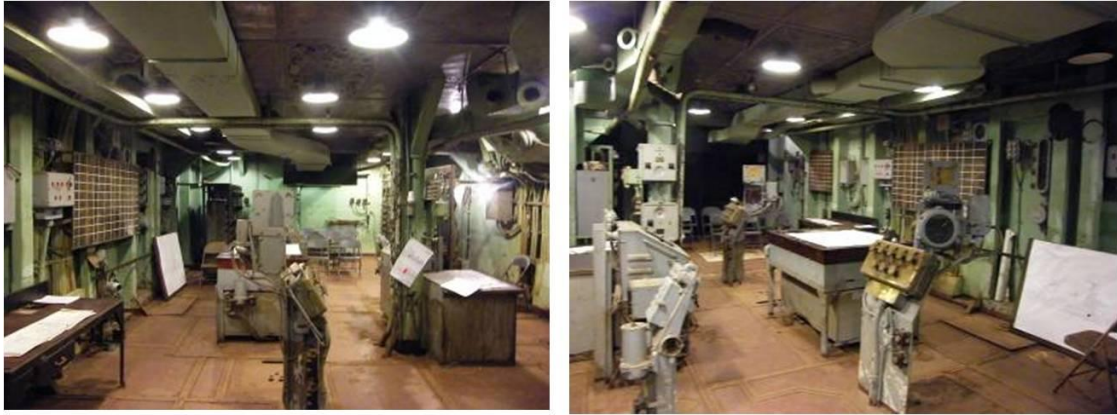
**Figure 310 Plotting and Secondary Conning Station (B-1-10)**

This space is in good structural and cosmetic condition. Much equipment has been removed from this public access space.

<p><b>Prepare, prime and paint space.</b></p>
---

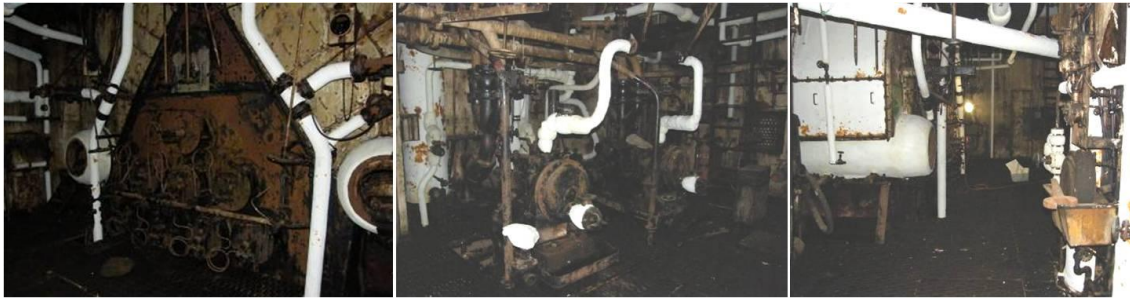
**Figure 312 B-2 Boiler Room (Frames No. 52 – 60 ½)**

The appearance of the boiler room is of a space that has not seen much upkeep since decommissioning with dried oil on many components, but no standing oil in the bilges. The paint system is failing throughout the space. Lighting could be vastly improved. The upper access ladder well has unsafe deck plating that should be repaired/replaced.

The foundations for the pair of boilers and the other major components within the boiler room are good with no signs of badly scaled or compressed plating and foundations.

The floor for these boilers and the other major components is wasted approximately 30% in places, but is not considered a problem at this time. Side shell on both sides appears fine with no leakage from outboard tankage, piping or manifolds.

**Inspect, repair/replace vertical stanchions supporting the deck gratings throughout the entire boiler room.**

**Repair/replace ladder well deck on both sides; repair ladders and handrails as needed; this is a serious trip/fall hazard.**

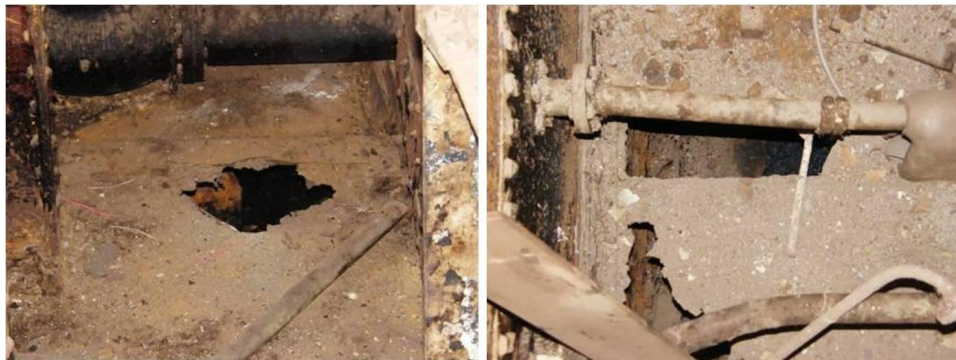
The floor for these boilers is completely wasted through in many areas allowing views within the underlying hold tankage with approximately additional 40 – 70 % wastage in places. The underlying support frames and longitudinal within the tankage in the hold and inner bottom is severely bent, totally wasted away or non-existent and showing ready signs of eventual collapse. The side shell on both sides appears fine with no leakage from outboard tankage, piping or manifolds.

**Figure 313 Wasted Flooring in Boiler Room B-3**

**Repair/replace boiler room deck plating and repair/replace wasted foundation footings on boilers and major components as needed to stabilize hull integrity.**

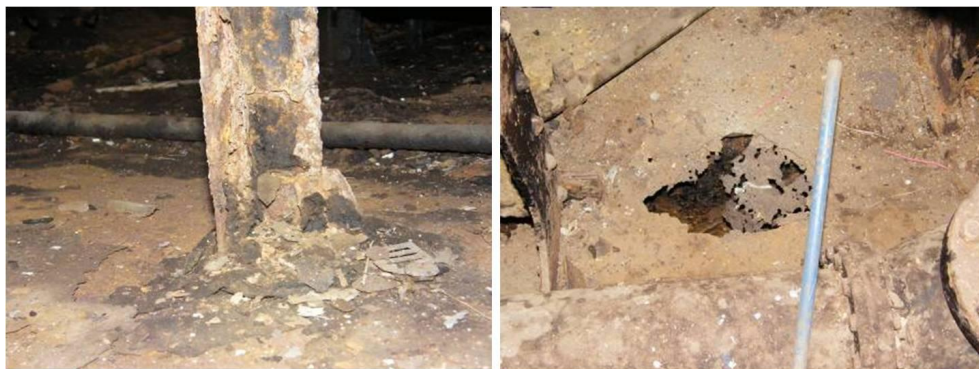
The foundations for the pair of boilers within the boiler room are starting to fail with signs of badly scaled or compressed plating and foundations.

**Figure 314 Wasted Vertical Stanchion (Left) and Foundation Plating (Right) in B-3 Boiler Room**

**Inspect, repair/replace vertical stanchions supporting the deck gratings throughout the entire boiler room.**

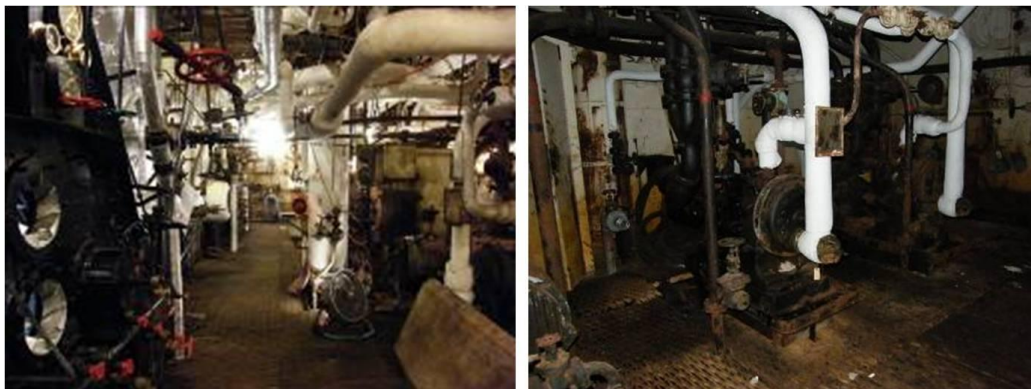
**Figure 315 Boiler Room B-4**

The appearance of the boiler room is of a space that has not seen much upkeep since decommissioning with dried oil on many components, and minor amounts of standing oil in the bilges. The paint system is failing throughout the space. Lighting could be vastly improved; although TPWD has made some improvements, lighting could not be turned on at time of inspection. Both upper access ladders wells have unsafe deck plating that should be repaired/replaced.

The foundations for the pair of boilers within the boiler room are starting to fail with signs of badly scaled or compressed plating and foundations.

The floor for these boilers is completely wasted through in many areas allowing views within the underlying hold tankage with approximately additional 40 – 70 % wastage in places. The underlying support frames and longitudinal within the tankage in the hold and inner bottom is severely bent, totally wasted away or non-existent and showing ready signs of eventual collapse under both boilers. The side shell on both sides appears fine with no leakage from outboard tankage, piping or manifolds.

**Inspect, repair/replace vertical stanchions supporting the deck gratings throughout the entire boiler room.**

**Repair/replace ladder well deck on both sides; repair ladders and handrails as needed; this is a serious trip/fall hazard.**

**Repair/replace boiler room deck plating and repair/replace wasted foundation footings on boilers and major components as needed to stabilize hull integrity.**

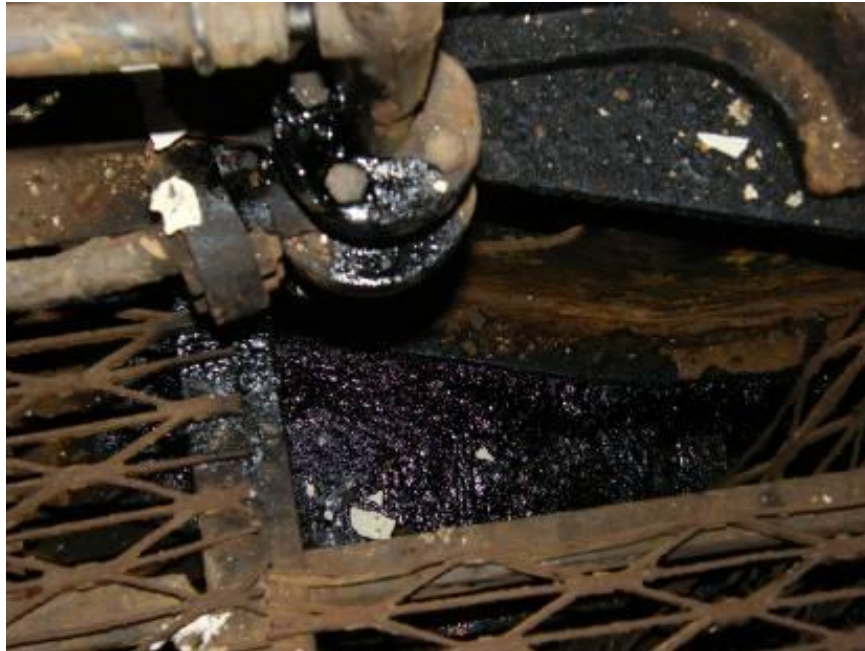
**Figure 316 Standing Oil in Bilges of B-4 Boiler Room**

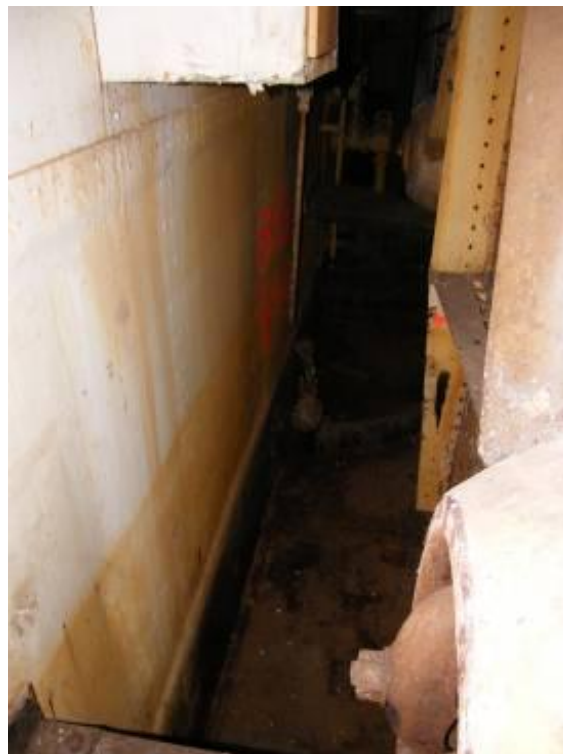
**Figure 317 Wasted Deck Plating in Front of Boiler in B-4 Boiler Room**

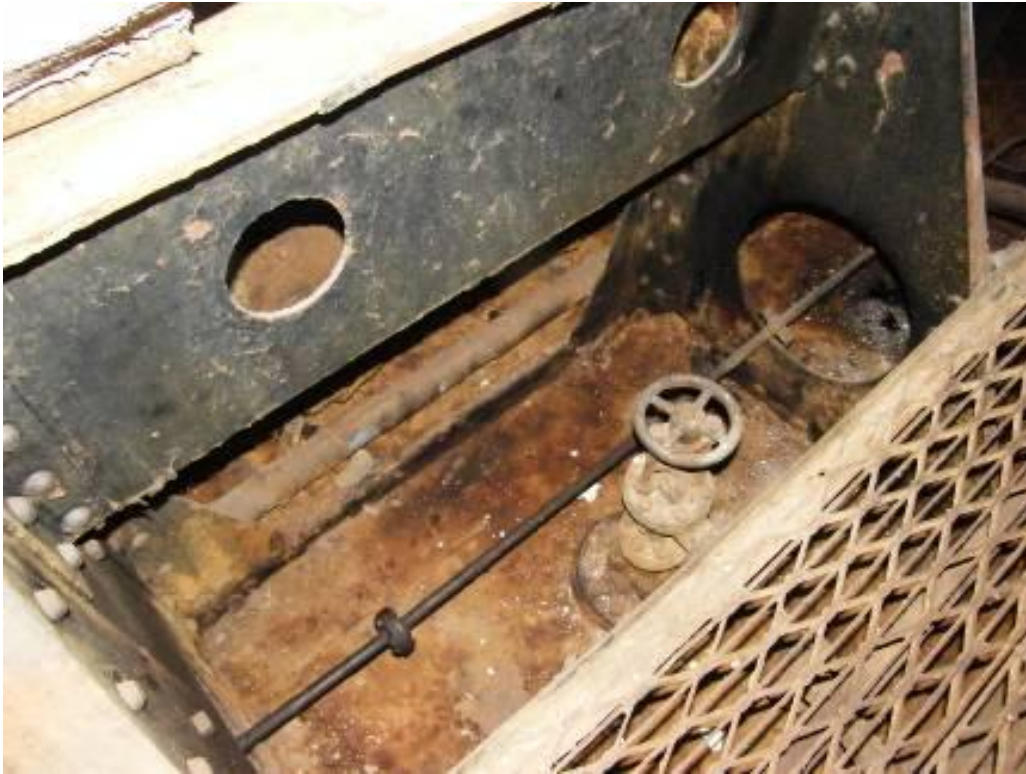
**Figure 318 Foundation of Boiler in B-4 Boiler Room (To Port)**

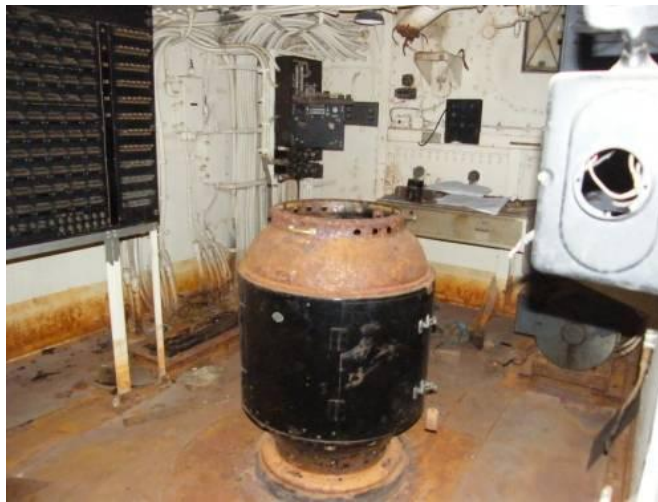
**Figure 320 Aft Dynamo Room (C-28, Frames No. 84 ½ - 9)**

This space is in fair structural and poor cosmetic condition. The deck is weak in many areas and needs to be repaired. Poor air quality within this and lower spaces should be improved with adequate ventilation. Lighting is poor or non-existent.

**Provide adequate ventilation to space(s)**

**Repair/replace deck as needed.**

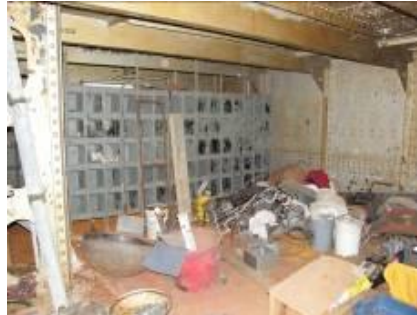
**Figure 322 G.S.K. Stores (D-15; Centerline)**

This space is in good structural and poor cosmetic condition. Miscellaneous gear is strewn about space.

**Prepare, prime and paint space.**

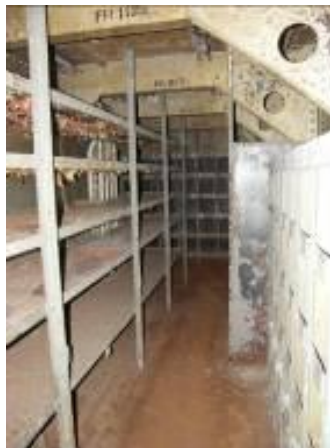
**Figure 323 Main Issuing Room (D-17; Port)**

This space is in good structural and poor cosmetic condition.

**Prepare, prime and paint space.**

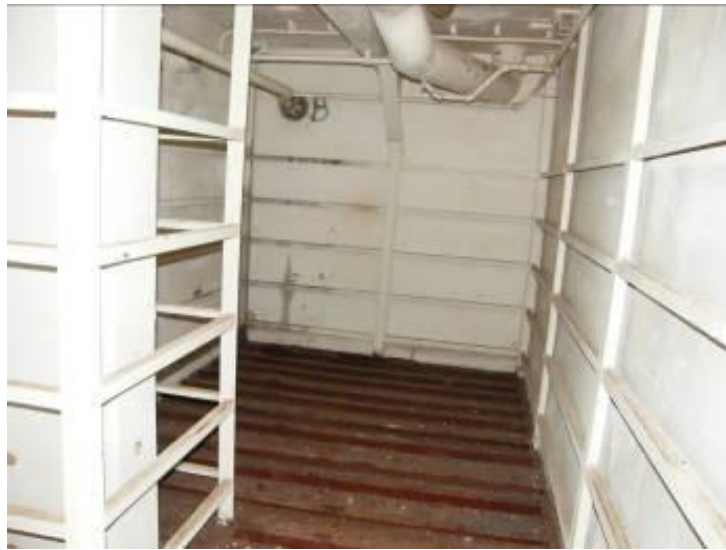
**Figure 325 40 MM Ready Service Room (D-18-M; Centerline)**

This space is in good structural and good cosmetic condition.

**Prepare, prime and paint space.**

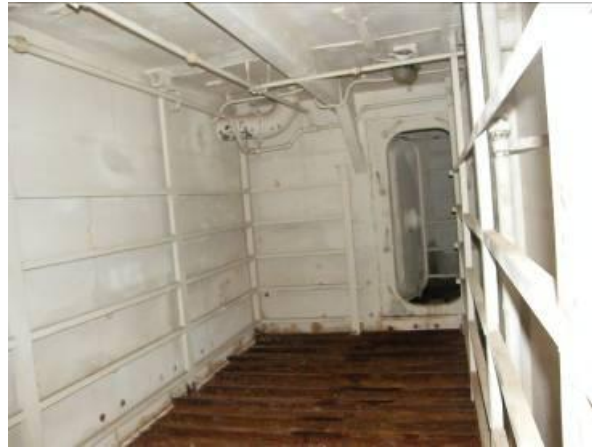
**Figure 326 20 MM Magazine (D-21M; Centerline)**

This space is in good structural and good cosmetic condition.

**Prepare, prime and paint space.**

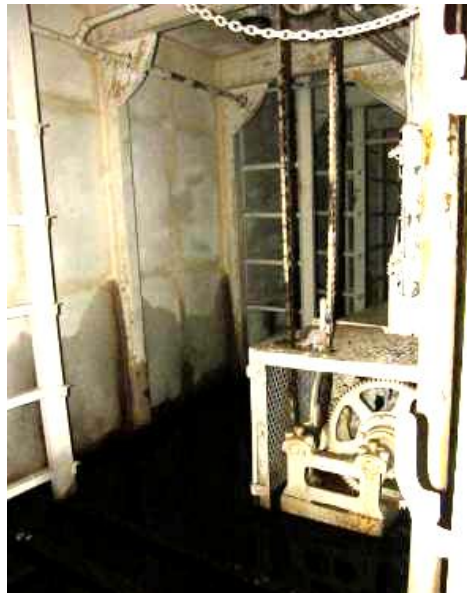
**Figure 327 40 MM Magazine (D-19-M-P; Port)**

This space is in good structural and poor cosmetic condition with standing oil and water on deck.

**Remediate oil/water in space. Find cause and seal.**

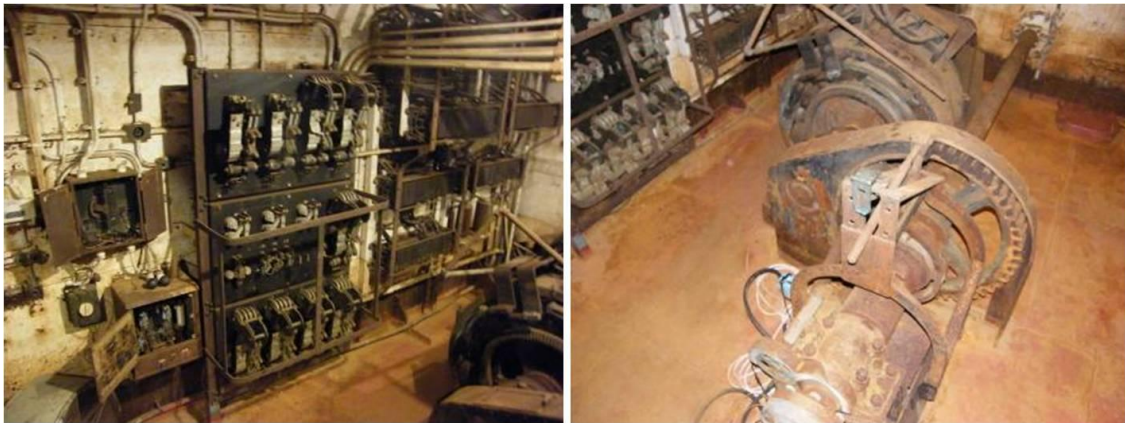
**Figure 329 Steering Room (D-25; Centerline)**

This space contains the main electrical and hydraulic control equipment powering the steering rams in the next space aft. An antique quad of wooden steering wheels are fitted, but are no longer attached to the steering assembly linkage.

This space has a badly corroded deck that needs repair; inspection by gauging showed wastage greater than 60-70% over a wide area. The overhead sheathing, support framing, bulkheads and vertical stanchions supporting the turtleback on the overhead sheathing have failed, or are soon to fail, due to corrosion. The deck itself is poorly supported by the transverse frames and stanchions within the Trimming Tank D-12. This entire area needs to be rebuilt to withstand the movement of the ship and to impart any strength while on the keel blocks to support everything under the Third Deck.

**Repair deck in space as needed.**

**Repair bulkheads (fore and aft) mainly at deckline as needed.**

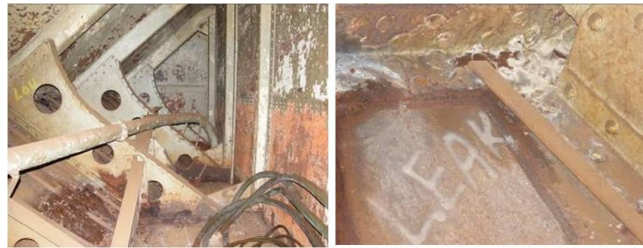
**Figure 330 Sanitary Diesel Pump Room (D-26S; Starboard)**

This space has a badly corroded deck that needs repair; inspection by gauging showed wastage greater than 60-70% over a wide area and holed plating. The overhead sheathing, support framing, bulkheads and vertical stanchions supporting the turtleback on the overhead sheathing have failed, or are soon to fail, due to corrosion. The outboard plating has badly deteriorated and will require repairs. The deck itself is poorly supported by the transverse frames and stanchions within the Trimming Tank D-12. There is not much here supporting the entire structure on the starboard quarter.

**Repair deck, framing and shell plating in space as needed.**

**Repair bulkheads (fore and aft) mainly at deckline as needed.**

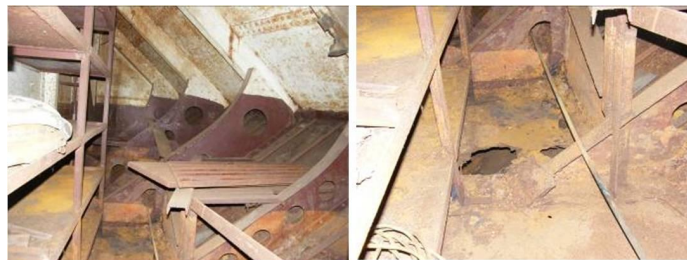
This space has a badly corroded deck that needs repair; inspection by gauging showed wastage greater than 60-70% over a wide area and holed plating. The overhead sheathing, support framing, bulkheads and vertical stanchions supporting the turtleback on the overhead sheathing have failed, or are soon to fail, due to corrosion. The outboard plating has badly deteriorated and will require repairs. The deck itself is poorly supported by the transverse frames and stanchions within the Trimming Tank D-12. There is not much here supporting the entire structure on the port quarter.

**Figure 331 Sanitary Pump Room (D-26P; Port) Showing Wasted Plating in Right Panel**

**Repair deck and framing in space as needed.**

**Repair bulkheads (fore and aft) mainly at deckline as needed.**

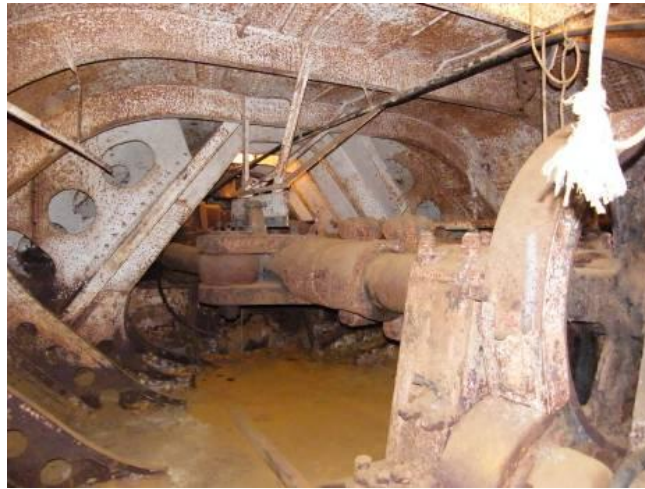
**Figure 332 View of Steering Room (D-27)**

This space contains the extremely heavy pair of hydraulic rams connected to the rudder post that steers the ship; these are very robust and locked in position to a 15 degree starboard turn. The condition of the space is poor structurally and poor cosmetically. The deck is wasted and holed, and is very dangerous.

Transverse web frames have failed entirely. The overhead is hanging over this space without much support. Outboard plating is in poor condition throughout. The deck frames and stanchions (themselves holed and badly wasted) supporting the heavy steering gear are badly corroded and rest on a badly corroded keel within Trimming Tank D-13. This entire area needs to be rebuilt to withstand the movement of the ship and to impart any strength while on the keel blocks to support everything under the Third Deck.

**Repair/replace existing transverse web frames as needed.**

**Repair deck in space as needed.**

**Repair bulkheads (fore and aft) mainly at deckline as needed.**

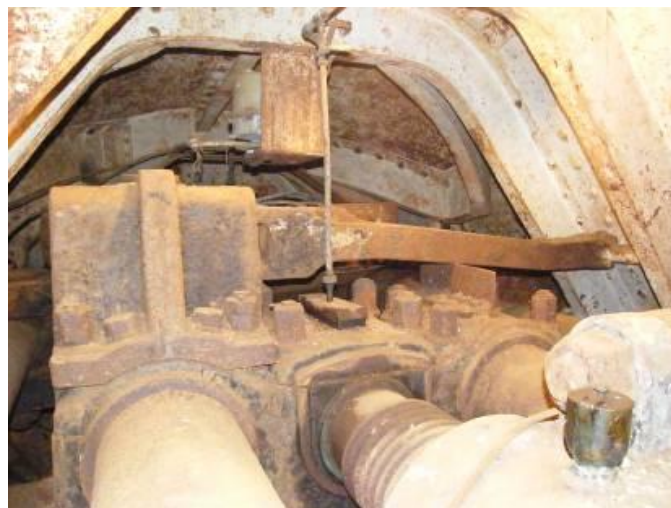
**Figure 333 Detail of Steering Rams at Crosshead Showing Waster Overhead Shell Plating of Turtleback Enclosure**

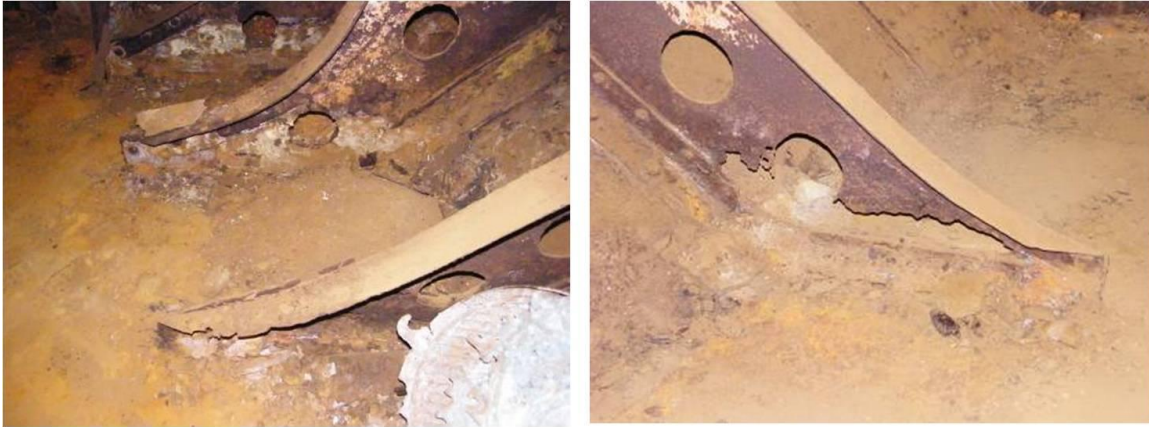
**Figure 334 Wasted Transverse Web Frames and Deck Plating in Steering Room (D-27)**

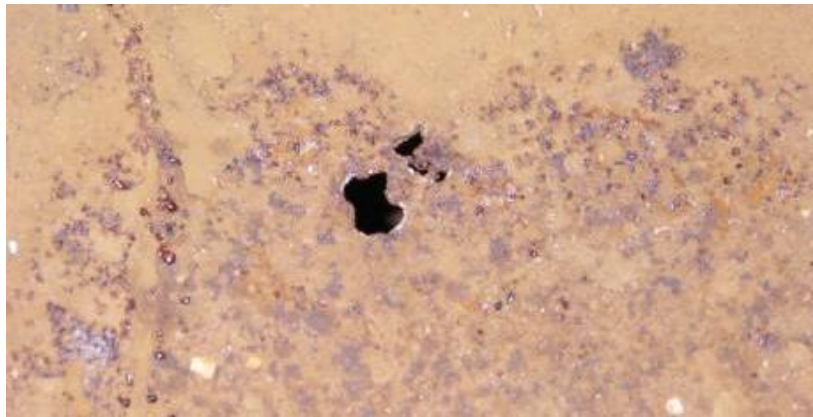
**Figure 335 Holed Deck Plating in Steering Room (D-27)**

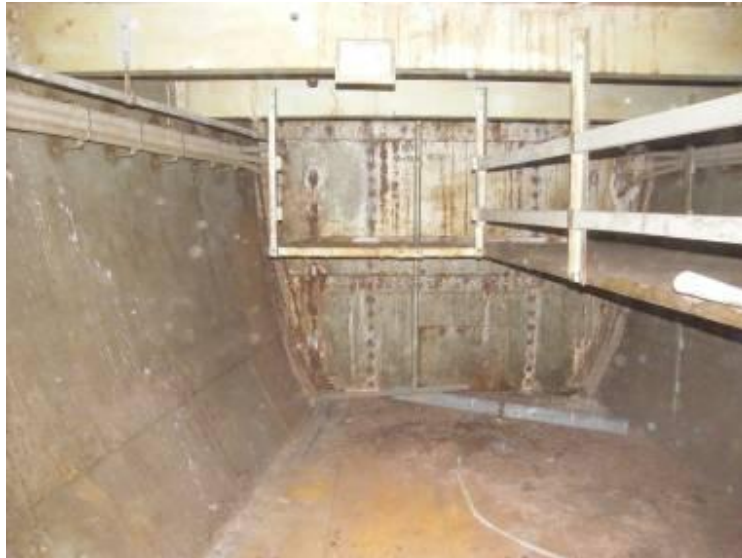
**Figure 337 Hawse and Cordage Storeroom (A-3, Frames No. 9 – 14)**

This space is in good structural and fair cosmetic condition.

<b>Prepare, prime and paint space.</b>
--

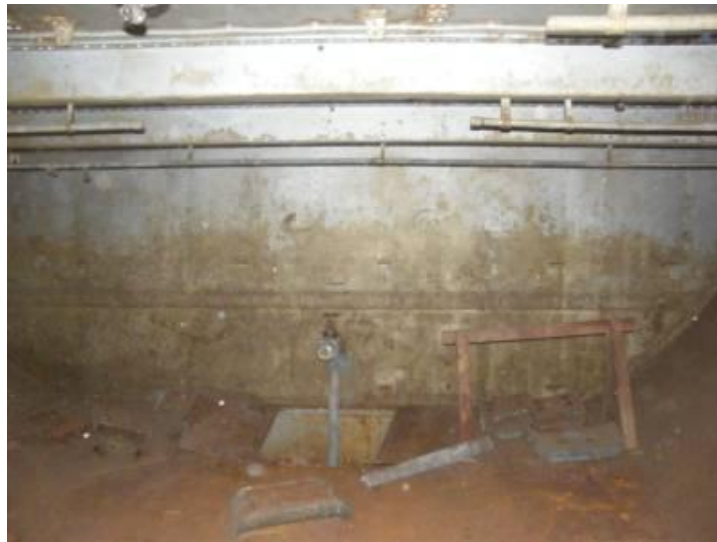
**Figure 338 C&R Stores (A-5, Frames No. 14 – 18)**

This space is in good structural and fair cosmetic condition.

<b>Prepare, prime and paint space.</b>
--

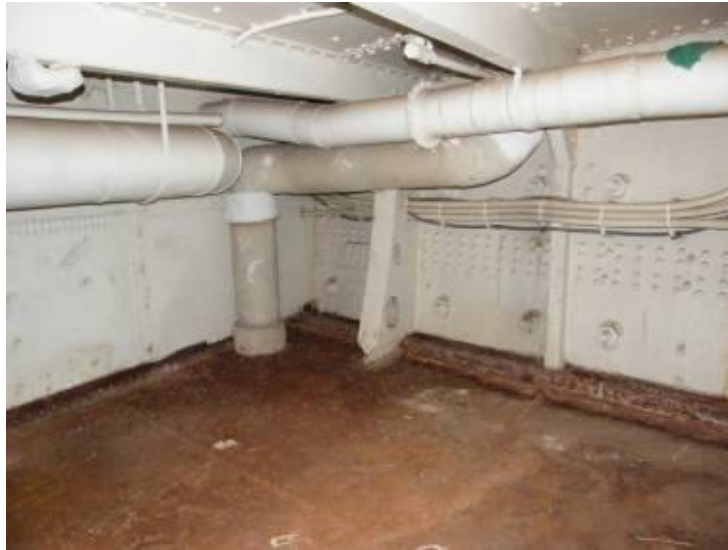
**Figure 339 Signal Storeroom (A-14S; Starboard)**

This space is in good structural and fair cosmetic condition.

<b>Prepare, prime and paint space.</b>
--

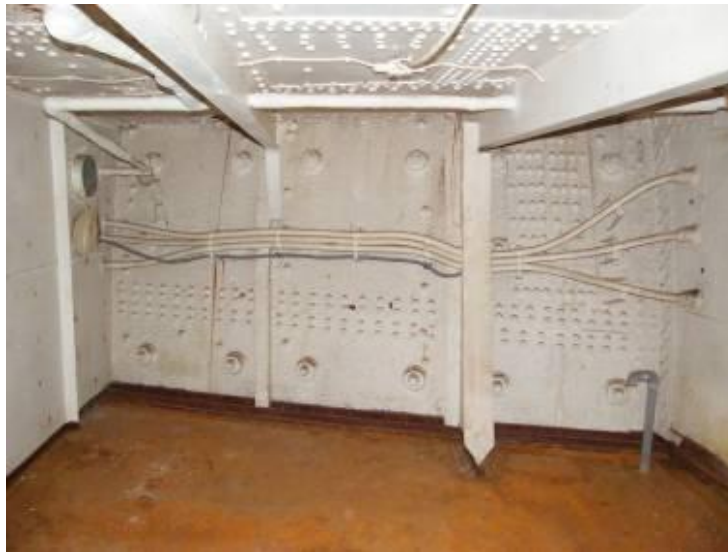
**Figure 340 GSK Storeroom (A-14 P; Port)**

This space is in good structural and fair cosmetic condition.

<b>Prepare, prime and paint space.</b>
--

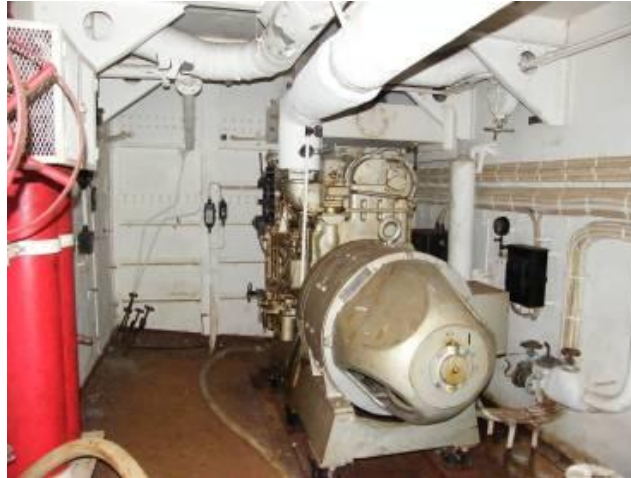
**Figure 341 Emergency Diesel Room (A – 13 S; Starboard)**

This space is in good structural and good cosmetic condition. The passageway just forward of this space has holed plating at the centerline. There is a bank of original CO-2 cylinders that should be carefully removed.

**Remove CO-2 cylinders from this space and properly dispose.**

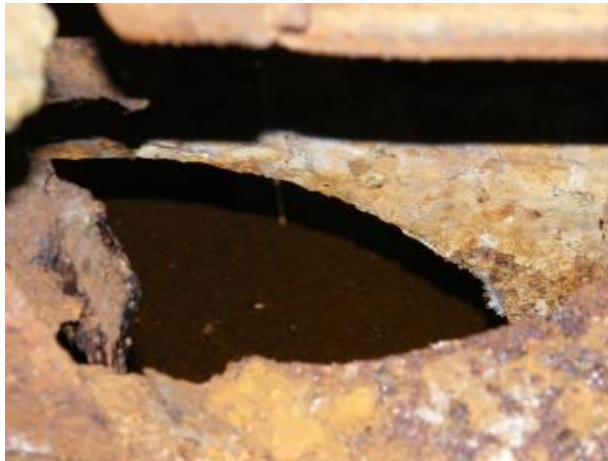
**Figure 342 Holed Deck Plating in Passageway Forward of Forward Emergency Diesel Room (A – 13S; Starboard)**

**Repair wasted passageway deck plating.**

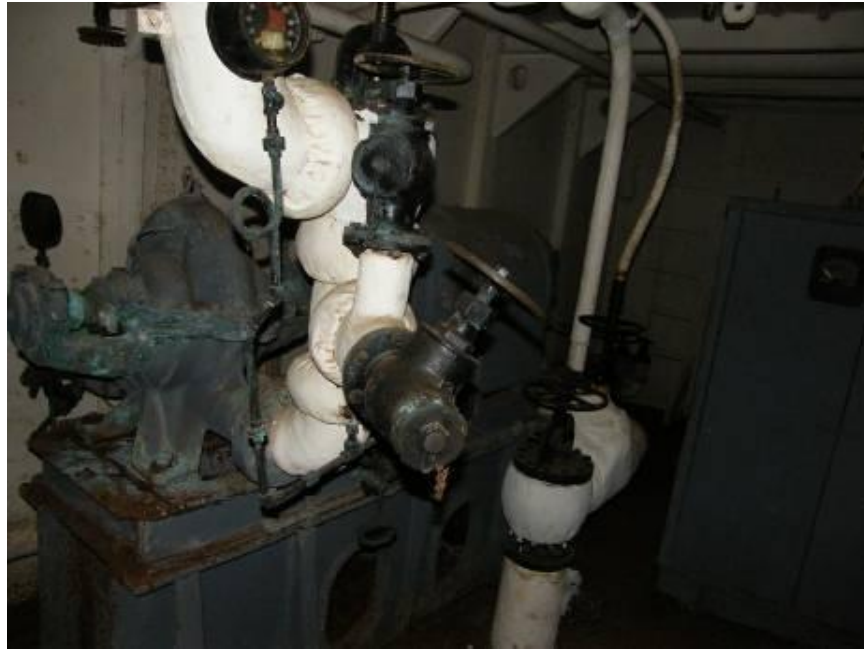
**Figure 343 Pump Room (A-13-P; Port)**

This space is in good structural and fair cosmetic condition.

<b>Prepare, prime and paint space.</b>
--

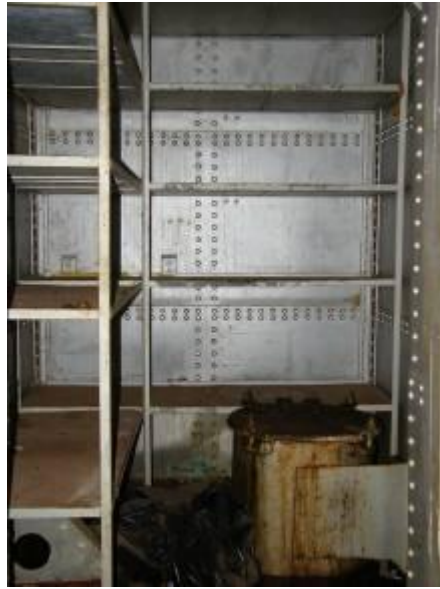
**Figure 344 Provisions Room (A-19; Centerline)**

This space is in good structural and fair cosmetic condition.

**Prepare, prime and paint space.**

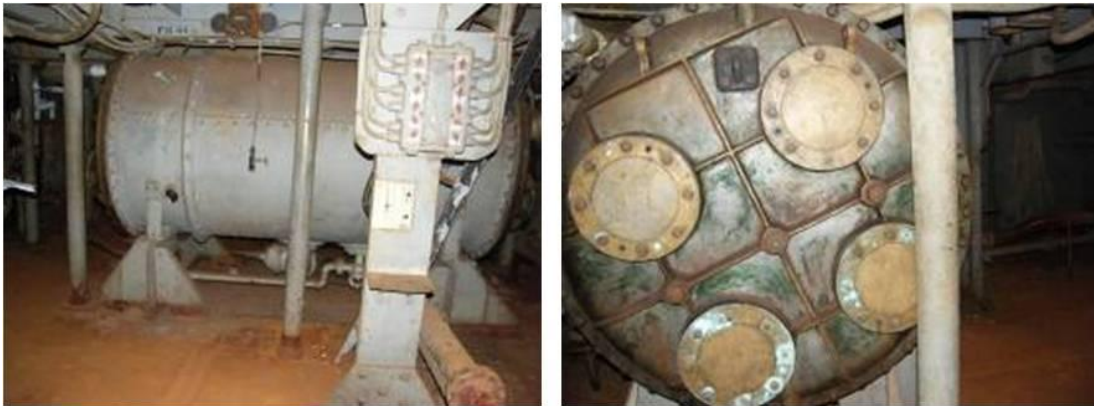
**Figure 345 Dynamo and Condenser Room (A-22)**

This space is in good structural and fair cosmetic condition.

**Prepare, prime and paint space.**

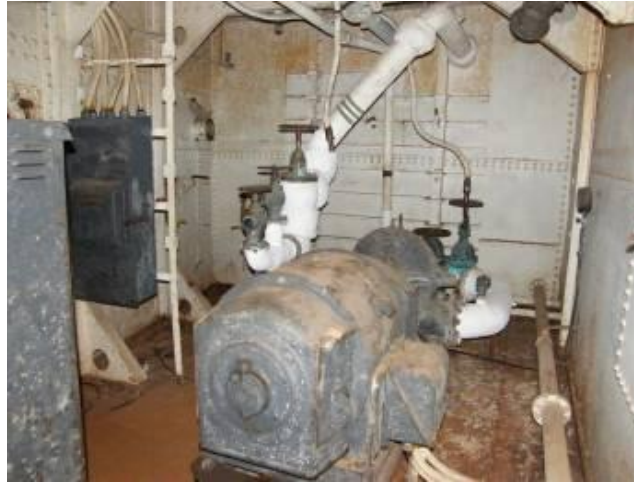
**Figure 346 Emergency Electric Fire Pump Room (A-24S; Starboard)**

This space is in good structural and fair cosmetic condition.

<p><b>Prepare, prime and paint space.</b></p>
---

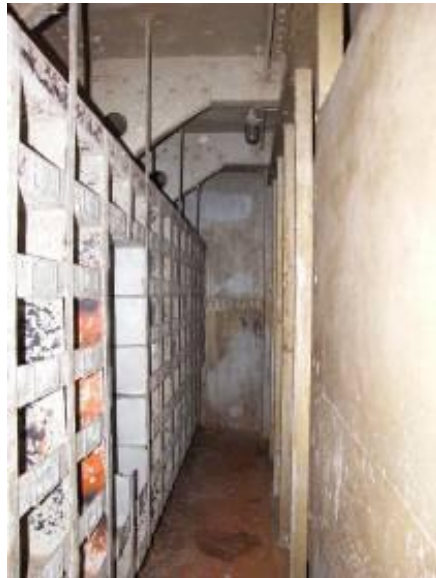
**Figure 347 Electrical Supply and Issuing Room (A-24P; Port)**

This space is in good structural and fair cosmetic condition.

<p><b>Prepare, prime and paint space.</b></p>
---

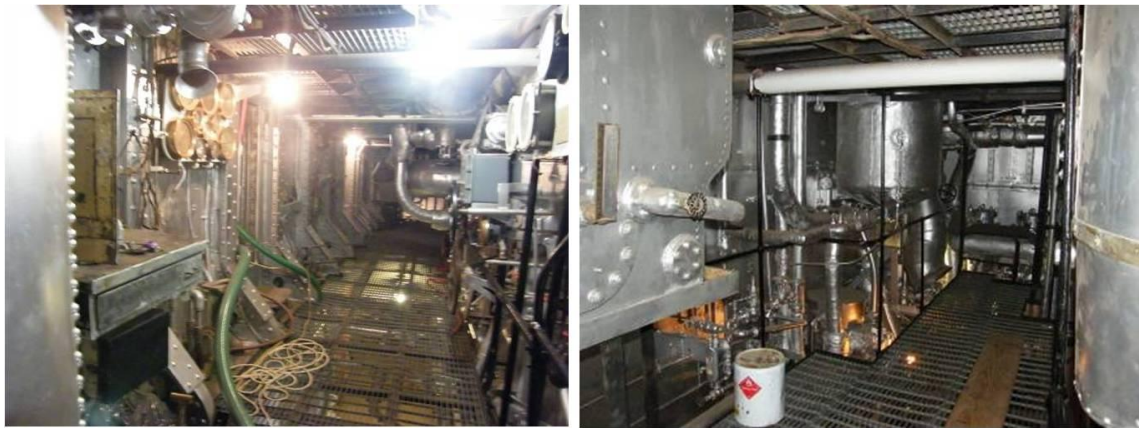
**Figure 350 Intermediate Flat in Engine Room C-1 (Starboard)**

Located to starboard, this space has seen extensive restoration efforts, being partially open to the public. The space is well lighted, has adequate handrails, excellent footing and grab rods. The space is in excellent cosmetic condition. This space is partially open to the public.

Of concern is the foundation for this engine in that the weight of this structure depends upon the strength of the underlying trio of inner bottom tank scantlings. There is very little 'meat' left within the scantlings below (engine room floor, transverse frames, longitudinal frames, keel) the main engine. The engine's base foundation has also been impacted by corrosion issues.

Other major components, foundations and platforms in this space are in fine shape but all suffer from a lack of support from the inner bottom tanks. Fore and aft bulkheads are holed with corrosion issues.

**Repair main engine foundation where possible. Consider a holistic approach to this repair and tie into repairs made to the underlying inner bottom tankage.**

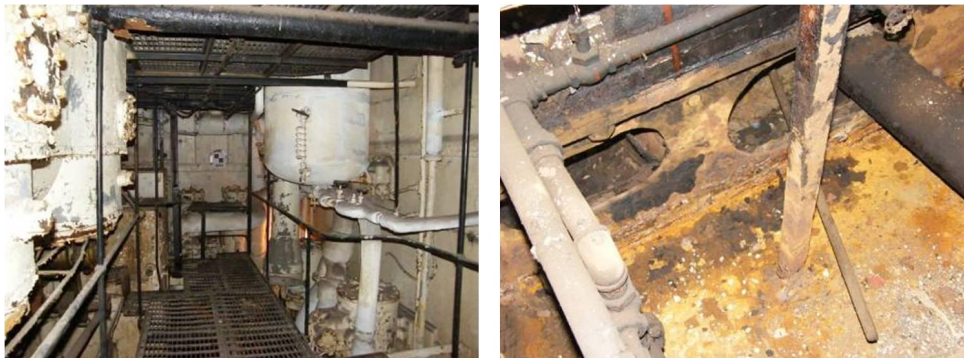
Located to port, this space has not seen extensive restoration efforts, and is not open to the public. The space is poorly lighted, has adequate handrails, excellent footing and grab rods. The space is in poor cosmetic condition.

Of concern is the foundation for this engine in that the weight of this structure depends upon the strength of the underlying trio of inner bottom tank scantlings. There is very little 'meat' left within the scantlings below (engine room floor, transverse frames, longitudinal frames, keel) the main engine. The engine's base foundation has also been impacted by corrosion issues.

Other major components, foundations and platforms in this space are in fine shape but all suffer from a lack of support from the inner bottom tanks. Fore and aft bulkheads are holed with corrosion issues.

**Figure 352 Intermediate Flat (Left Panel) and Foundation Under Main Engine in Engine Room C-2 (Starboard)**

**Repair main engine foundation where possible. Consider a holistic approach to this repair and tie into repairs made to the underlying inner bottom tankage.**

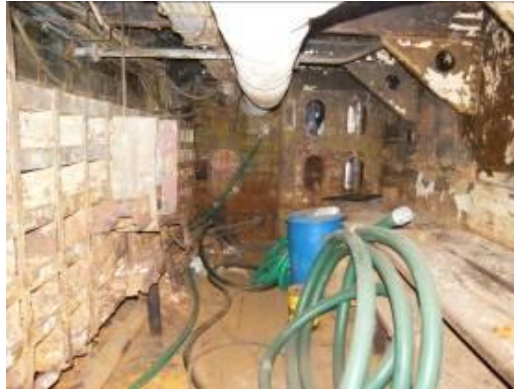
**Figure 353 Engineer Stores (D-1)**

This space is in poor structural and poor cosmetic condition. Deck is perforated in several areas, especially adjacent to both bulkheads. Watertight dogging door is in need of repair.

**Repair dogging watertight doors as needed.**

**Repair/replace deck as needed. Repair forward and aft bulkhead as needed.**

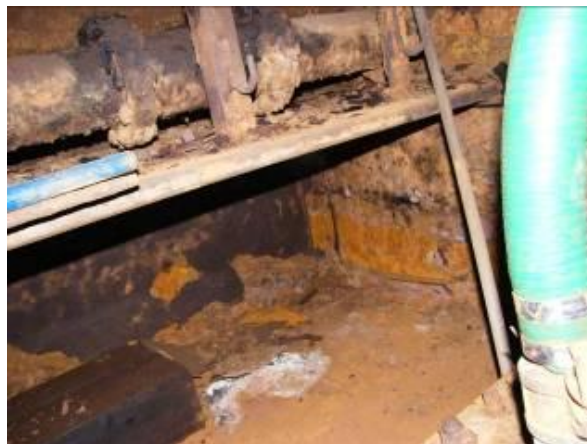
**Figure 354 Engineer Stores (D-7)**

This space is in poor structural and poor cosmetic condition. Deck is perforated in several areas, especially adjacent to both bulkheads. Watertight dogging door is in need of repair.

**Repair dogging watertight doors as needed.**

**Repair/replace deck as needed. Repair forward and aft bulkhead as needed.**

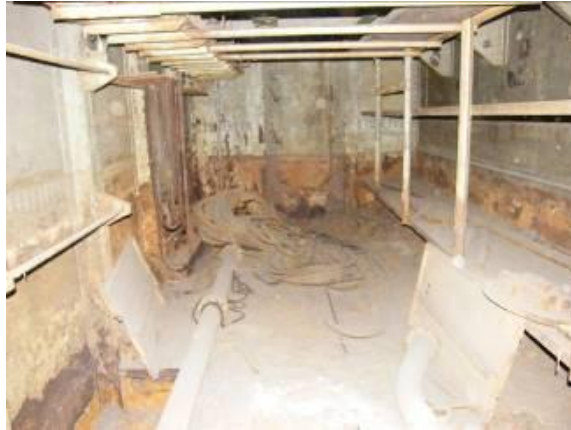
**Figure 355 Engineer Stores (D-2)**

This space is in poor structural and poor cosmetic condition. Deck is perforated in several areas, especially adjacent to both bulkheads. Watertight dogging door is in need of repair.

**Repair dogging watertight doors as needed.**

**Repair/replace deck as needed. Repair forward and aft bulkhead as needed.**

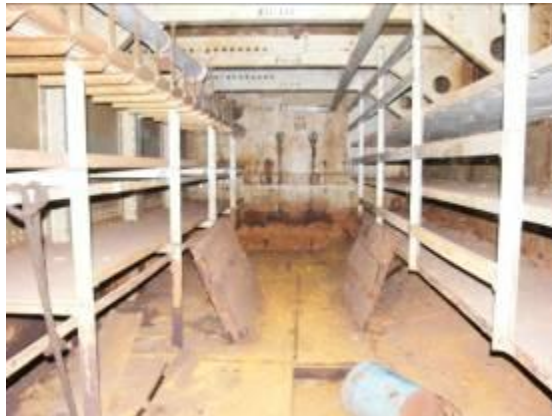
**Figure 356 Engineer Stores (D-8)**

This space is in poor structural and poor cosmetic condition. Deck is perforated in several areas, especially adjacent to both bulkheads. Watertight dogging door is in need of repair.

**Repair dogging watertight doors as needed.**

**Repair/replace deck as needed. Repair forward and aft bulkhead as needed.**
